⑮ 考案の名称 運搬容器体におけるシール材

(11) Japanese Examined Utility Model Publication No. H4-35409

(54) Title of the device: SEAL MATERIAL IN TRANSPORTATION
CONTAINERS

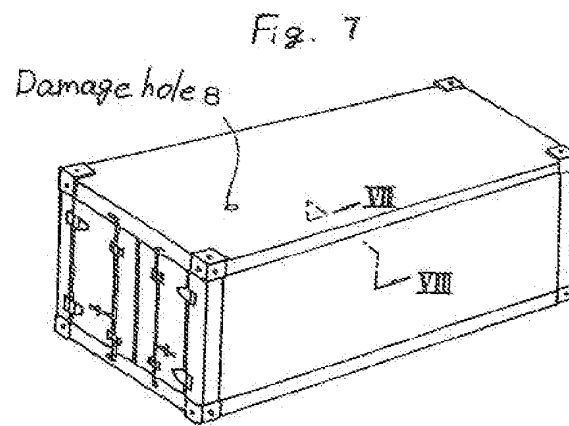
Fig. 1 shows a sectional view of a seal material. Fig. 2 shows a state before use where a release sheet is attached. Fig. 3 shows an example a seal material is applied to a lapping part of boards. Fig. 4 shows an example which a seal material is applied to a lapping part of boards combined with a rivet. Fig. 5 shows an example in which a seal material is applied to a lapping end of boards. Fig. 6 shows an example in which a seal material is applied to a damage hole in a roof panel. Fig. 7 is a perspective

view of a container. Fig. 8 is a cross sectional view taken along the line VIII-VIII of Fig. 7. Fig. 9 shows a method of fixing a part viewed along the arrow IX in Fig. 8.

Fig. 7 is a perspective view of a marine container. Fig. 8 shows a cross section taken along the VIII-VIII line in Fig. 7, namely a structure of a connecting portion of an upper frame 1 and a roof panel 2 and a side panel 3 each fixed to the frame 1.
